SERVI-SERIES by **BERNAL OSBORNE**

Overhauling the
BURMAN
GEARBOXES

Routine Applicable to a Series
of Generally Similar Design

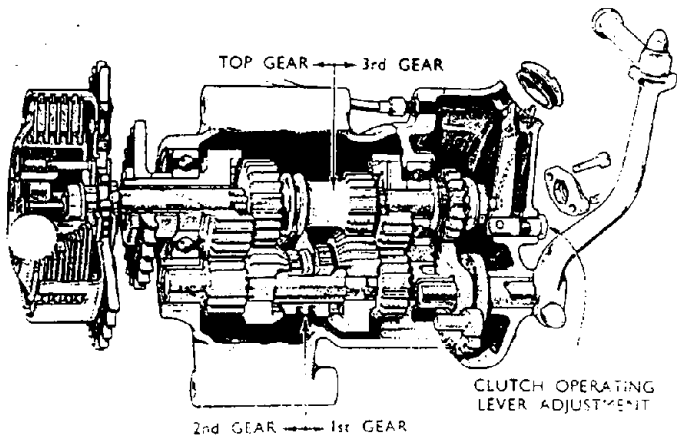
Cutaway impression of the "CP" type box and standard clutch, showing gear movements to obtain the four ratios.

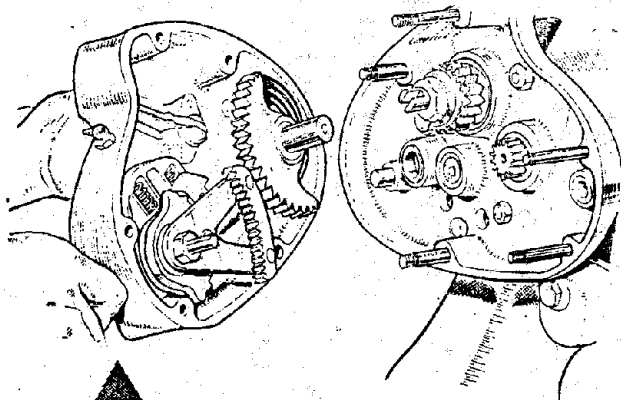
ACCESS to the kickstart mechanism, including the spring and ratchet assembly, and to the gear selector parts, is by removing the outer cover, retained by three $\frac{1}{4}$ -in. and two $\frac{1}{8}$ -in. nuts. Use the gear pedal and k.s. crank as "handles" to pull the cover free.

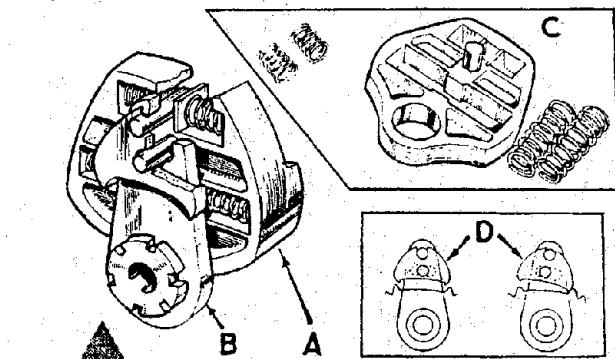
OPERATE the pedal, watching the movement of the gear selector spring-box "A" and pawl carrier "B"; wash away residual lubricant with petrol and a stiff brush and observe the action of the two sets of captive springs (shown dismantled at "C") and the two pegs in tilting the pawl "D" to move the selector ratchet.

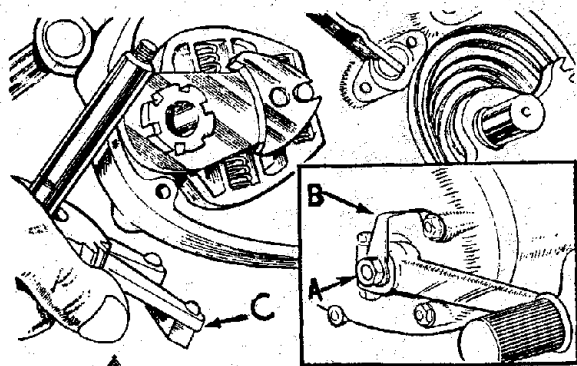
TO dismantle outer parts, slacken the nut "A" and take off the indicator pointer "B." Unscrew the pinch-bolt and pull off the lever. Turn to the inner assembly and inspect the two rivets that secure the ratchet sector to the quadrant fork ends "C"; re-rivet if slack.

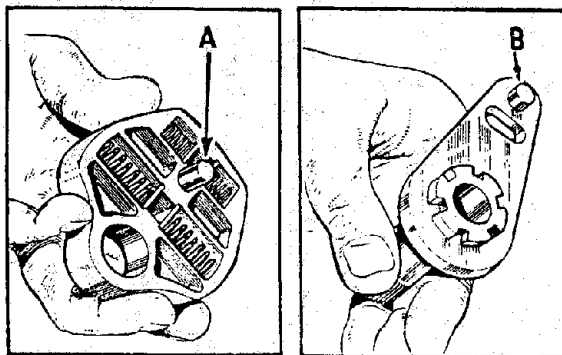
THE $\frac{1}{8}$ -in. peg "A," forming a bearing for the trip pawl, must be a tight fit. The peg "B" also must be unworn and secure. Weld or braze this peg if it is loose, otherwise gear selection will be uncertain. Wear of the small springs is unlikely, but renew either of the larger pair if more than $\frac{1}{4}$ in. under length.

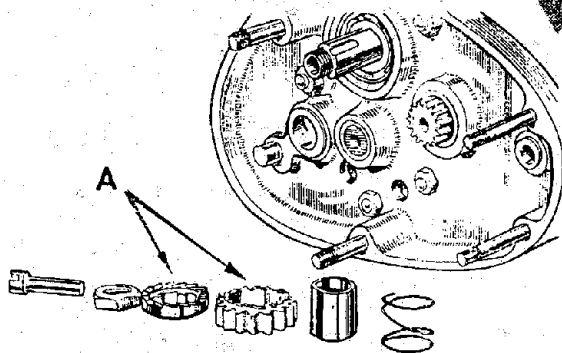
NEGLECT of a broken k.s. spring may have let the crank drop, partially engaging (and therefore wearing) the face-ratchet "A" while the engine is running. Stripping involves removing (l. to r. in sketch): clutch-thrust plunger, $\frac{1}{2}$ -in. 20 t.p.i. mainshaft nut, ratchet and pinion, sleeve-bush and spring.

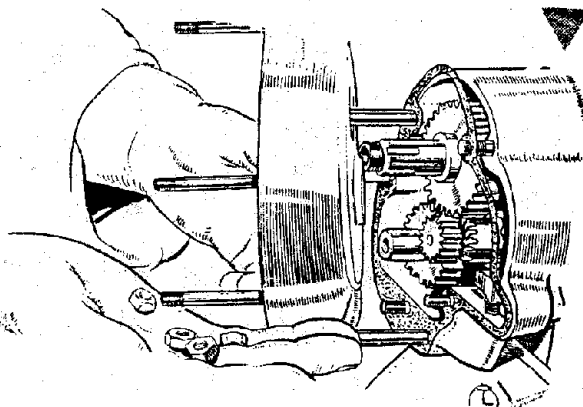
THE inner cover is retained by $\frac{1}{4}$ -in. (2) and $\frac{1}{8}$ -in. (2) nuts and studs without washers. When the nuts are removed there should be no difficulty in pulling free the cover. If the box has been used with oil as a lubricant, some residue will drip away as the seal is broken.
